# Belzona protect new water distribution pipework

ID: 8079

Customer Location: *Water treatment plant, France*

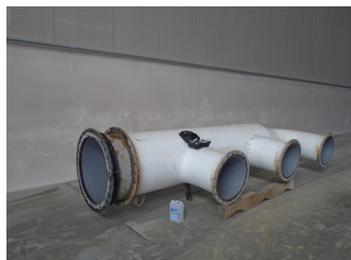
- \* 1- Section of pipework (4 in total) ,
- \* 2- Application of Belzona 5821 completed ,
- \* 3- Inspection in progress ,

Hand application of Belzona 5821 followed by a thorough inspection to ensure that the application was carried out as per the Instructions For Use.
