Belzona protect new water distribution pipework

ID: 8079

Protection against corrosion / erosion on new sections of pipework

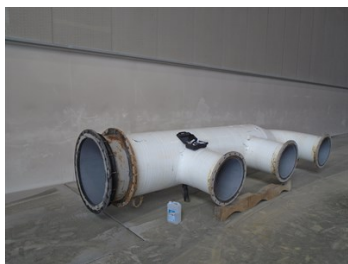
- * 1- Section of pipework (4 in total) ,
- * 2- Application of Belzona 5821 completed ,
- * 3- Inspection in progress ,

New pipework system, 300m2 in total (including 4 large pipework sections, 52 bends and 5 tees)

Hand application of Belzona 5821 followed by a thorough inspection to ensure that the application was carried out as per the Instructions For Use.
