BELZONA REPAIRS GEAR BOX OF DREDGER

ID: 808

Customer Location: Dredger, Egypt
Application Date: August 2006

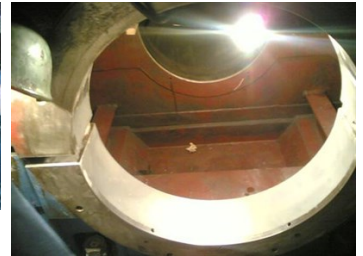
Bearing housing of the gear box was badly worn due to bearing failure.

* View of the dredger cutter shaft gear box , * Worn out bearing housing , * Form was applied, then Belzona injected through the former , * Gear box bearing housing perfectly rebuilt ,

Belzona successfully repaired the bearing housing insitu without machining which would have been difficult due to the large size of the gearbox.
