# Belzona Repairs and Protects Oil/Gas/Water Separator

ID: 8083

Customer Location: Romania  
Application Date: June 2019

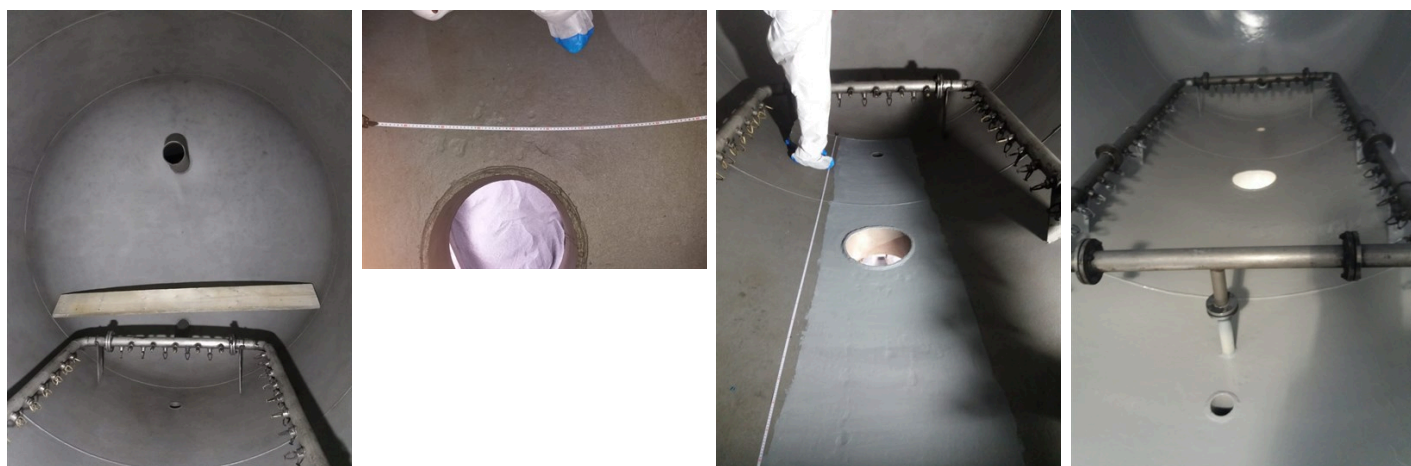
General pitting corrosion on the wall and severe erosion-corrosion in the lower section of separator due to the presence of sour gas.

- \* 1. General view inside separator after grit blasting ,
- \* 2. Corrosion in the wall ,
- \* 3. Repair of corrosion areas ,
- \* 4. Completed application ,

The application was carried out in accordance with Belzona Know-How System Leaflets TCC-5. The separator surface was cleaned, degreased and grit blasted. Following the grit blasting, stripe coating of all internal weld areas and outer edges were completed and

areas of severe corrosion and pitting were identified and repaired using Belzona 1111 Super Metal. A two coat system of Belzona 5892 was applied to protect the separator from further corrosion. The lower section of the first separator stage was then coated with two layers of Belzona 1381 for added erosion-corosion resistance.
