Belzona 5721 Protects Wind Turbine Blades' Leading Edges in a Single Coat

ID: 8084

Customer Location: Yorkshire, UK
Application Date: August 2019

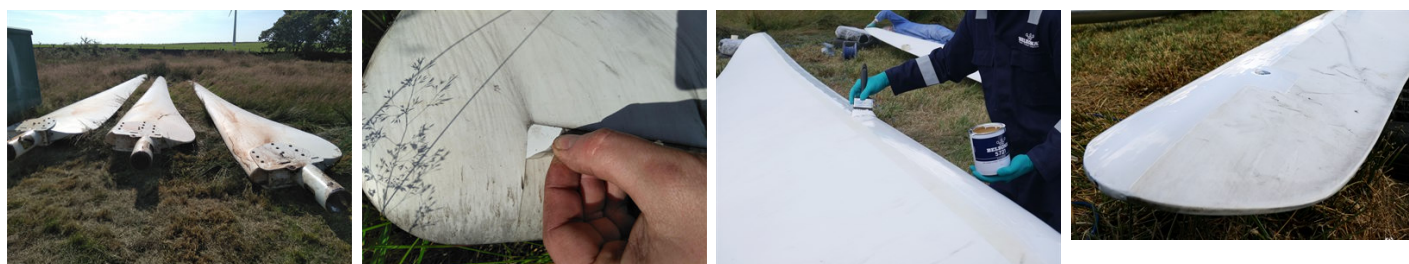
Photograph Descriptions

The wind turbine blades were suffering from damage due to rain erosion and from mechanical lifting of the blades. The existing tape system had begun to peel in patches, as well as some noticeable areas of erosion and impact damage present through the tape.

- * 1. Blades taken down from the turbine before cleaning ,
- * 2. Existing tape system had started to peel ,
- * 3. After preparation, Belzona 5721 was applied to the leading edge ,
- * 4. Finished LEP application ,

The blades were removed by the asset owner for inspection and general cleaning, before the existing tape system was removed. Positioned on stands at 45°, the area to be coated was masked off and sanded using an orbital sander and then cleaned of any debris. Belzona 5721 was mixed and applied by brush to a band of 20cm (8") around the leading edge in a single coat. Finally, the masking tape was removed before the coating could fully cure.
