Belzona Impeller Repair

ID: 8086

Customer Location: Wrexham, United Kingdom
Application Date: February 2019

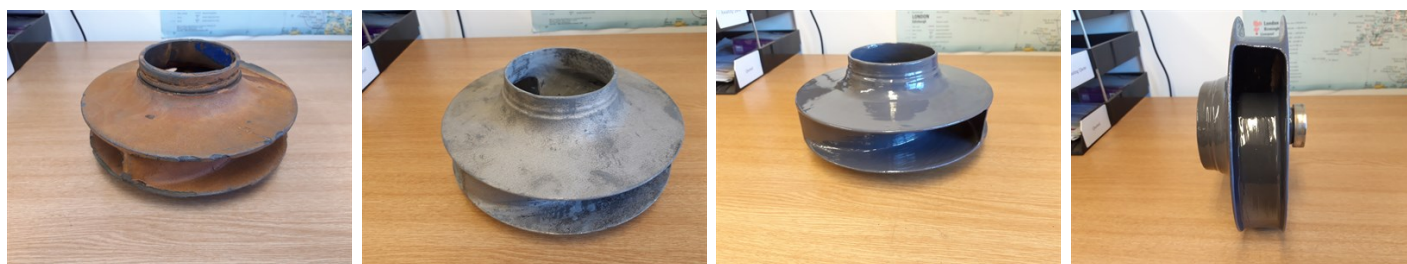
The pump and impeller were corroded due to contact with sulfuric acid at approximately 20% concentration, caused by back feed into the system, with the primary contact of waste or rinse water.

- * Damaged impeller with corrosion after being exposed to sulfuric acid and water. ,
- * Impeller profile restored using Belzona 1311 (Ceramic R-Metal). ,
- * Belzona 4311 (Magma CR1) coated impeller. ,
- * Side-view of the finished coated and rebuild impeller. ,

Application carried out as per Belzona Know-How System Leaflets CEP-1 & CEP-3. Surface contamination was removed and degreased with Belzona 9111, then blasted the surface to achieve SA 2 ½. The impeller was then rebuilt to profile using Belzona 1311 and reinforcing materials. Two coats of Belzona 4311 was then applied to protect against further chemical attack.
