# Belzona Impeller Repair

Industry: Fluid Flow  
Application: CEP-Centrifugal Pumps  
Substrate: Steel  
Products: \* Belzona 1311 (Ceramic R-Metal) ,  
\* Belzona 4311 (Magma CR1) ,  
\* Belzona 9111 (Cleaner Degreaser) ,

Customer Location: Wrexham, United Kingdom  
Application Date: February 2019

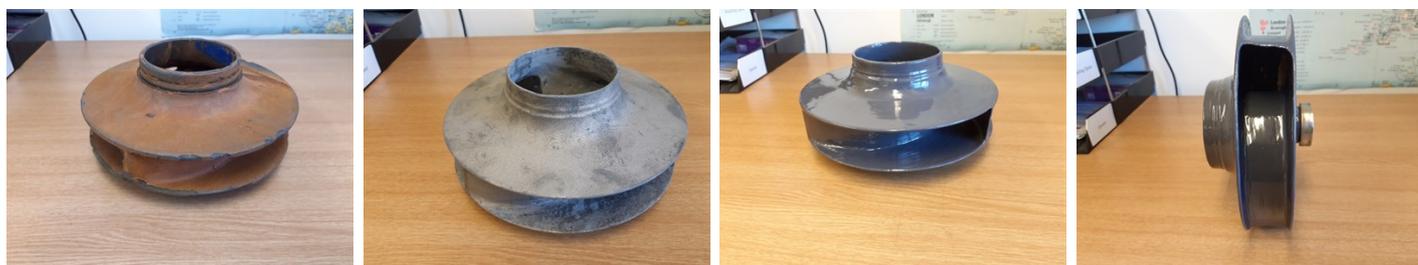
The pump and impeller were corroded due to contact with sulfuric acid at approximately 20% concentration, caused by back feed into the system, with the primary contact of waste or rinse water.

- \* Damaged impeller with corrosion after being exposed to sulfuric acid and water. ,
- \* Impeller profile restored using Belzona 1311 (Ceramic R-Metal). ,
- \* Belzona 4311 (Magma CR1) coated impeller. ,
- \* Side-view of the finished coated and rebuild impeller. ,

Application carried out as per Belzona Know-How System Leaflets CEP-1 & CEP-3. Surface contamination was removed and degreased with Belzona 9111, then blasted the surface to achieve SA 2 ½. The impeller was then rebuilt to profile using Belzona 1311 and reinforcing materials. Two coats of Belzona 4311 was then applied to protect against further chemical attack.
