Belzona 1321 in use at a large Sawmill in the Baltics

ID: 8093

Application: SHM-Solids Handling Machinery

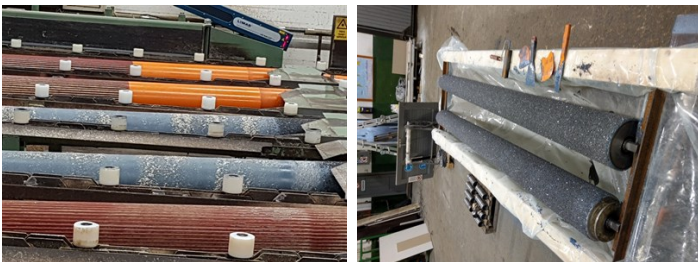
Photograph Descriptions

Worn lumber transfer rollers lack the required grip to transfer lumber quickly and efficiently. This inefficiency affected the ability of transferring lumber from one part of the plant to another, which was affecting revenue and production levels.

- * Rolls grip system worn smooth ,
- * Application of Belzona 1321 and Belzona 9211 ,

Grip Rollers in Lumber Mill were worn causing inefficient transfer of lumber system.

Products: * Belzona 1321 (Ceramic S- Metal) ,
* Belzona 9211 (Supergrip Aggregate) ,

The application was carried out in accordance with Belzona Know-How Leaflet SHM-12
