# Belzona 1812 in use at Peat Power Plant

ID: 8094

Industry: *General Industry*  
Application: *SHM-Solids Handling Machinery*

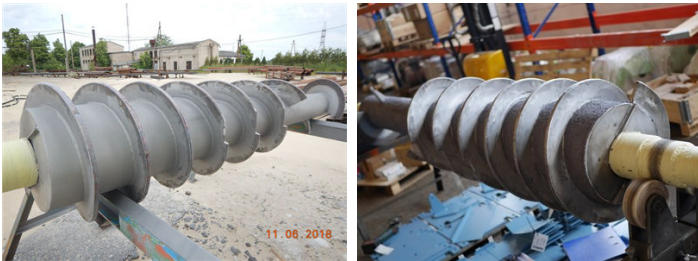
*It is very time consuming and costly for the client. Welding would make the pipe fragile and very difficult to use post-process.*

- \* Screw before Belzona coating ,
- \* Screw complete with Belzona coating ,

The customer's drawing shows that the screw tube must be welded with a hard facing CASTOLIN 5006. Screw was used for transporting peat.

Application was carried out in accordance with Belzona leaflet SHM-14. Grit blasting was used to prepare the surface, followed by a lining of Belzona 1812

Little down time for the customer and saving them money contributed to winning the job. According to the customer feedback, the screws have been working for a year and there is no sign of wear.
