# BELZONA PROVIDES COST EFFECTIVE MAINTENANCE OF OIL CENTRIFUGES

**Industry:** Oil & Gas  
**Application:** TCC-Tanks and Chemical Containment Areas  
**Substrate:** Steel  
**Products:** \* Belzona® 1321 (Ceramic S-Metal) ,

**Customer Location:** International Supplier of Oil Equipment  
**Application Date:** Ongoing since March, 1994

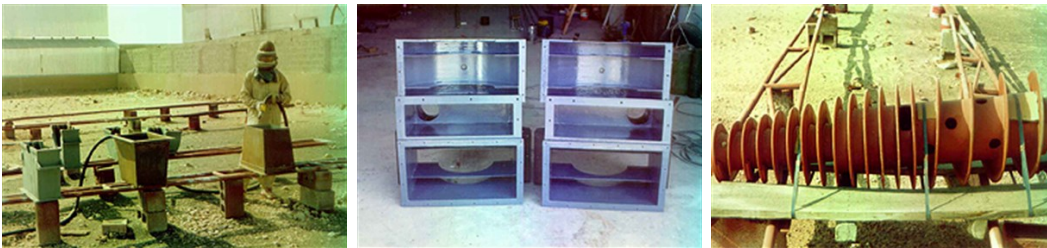
## Photograph Descriptions

The units revolve at 3500rpm. and the sand particles cause severe erosion requiring the units to be completely overhauled on an annual basis.

- \* Centrifuge components being grit blasted. ,
- \* Some of the components after coating with Belzona® 1321. ,
- \* The scroll from a centrifuge. ,

The application is carried out in accordance with Belzona Know-How Leaflet TCC-3.

Service life of Belzona® 1321 is 12-18 months at which point minor touch-up is required. The Belzona application is a third the cost of the previous annual overhaul at \$10,000.
