Belzona Provides Bonding Solution for Tank Stairs

ID: 8100

Industry: Oil & Gas
Application: VPF-Valves, Pipes and Fittings
Substrate: Steel
Products: * Belzona 1161 (Super UW-Metal) ,
* Belzona 5811 (Immersion Grade) ,

Customer Location: Italy
Application Date: 2018

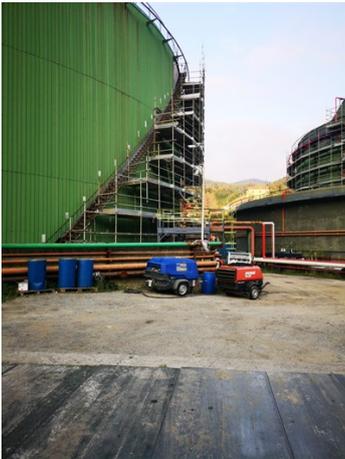
- * 1. Overview of tank stairs ,
- * 2. Severe galvanic corrosion ,
- * 3. Belzona 1161 bonding the stairs to the tank ,
- * 4. Finished application with a coating of Belzona 5811 ,

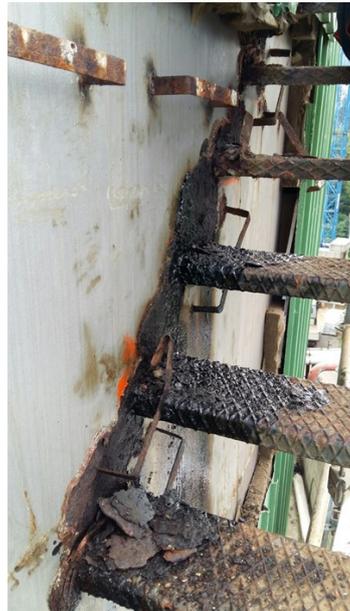
Stairs on the side of the tank suffering from severe galvanic corrosion, deeming the stairs unsafe to use.

This application was carried out using a modified version of system leaflet VPF-15. The stairs were power washed and chiseled down to get rid of any loose contaminants. Once the stairs were cleaned the side of the tank and the bonding side of the stairs were grit blasted to Sa 2.5 before Belzona 1161 was used to bond the two surfaces together. Belzona 9341 was also incorporated into the

paste grade for added support. Once the Belzona 1161 had cured a final coat of Belzona 5811 was applied for added corrosion resistance.
