Belzona Repairs Leaking Tank Roof

Industry: Oil & Gas
Application: TCC-Tanks and Chemical Containment Areas
Substrate: Steel
Products: * Belzona 1161 (Super UW-Metal) ,
* Belzona 3111 (Flexible Membrane) ,
* Belzona 9311 ,

Customer Location: Italy
Application Date: 2019

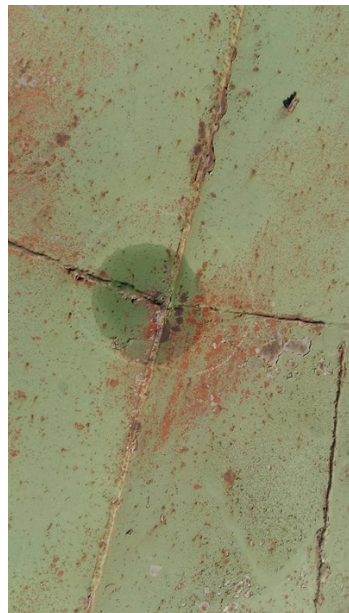
- * 1. Overview of the tank roof ,
- * 2. Water ingress at the weld seams ,
- * 3. Belzona 1161 being applied ,
- * 4. Finished application with Belzona 3111 ,

This application was carried out in accordance with system leaflet TCC-02. Areas where the tank roof was leaking from were identified and taped out. Once taped out the surface was prepared using an MBX bristle blaster. Belzona 1161 was then used to fill in the leaks before Belzona 3111 was applied on top with a cut out strip of Belzona 9311 reinforcement sheet for added protection.

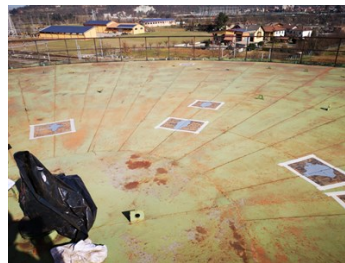
A tank roof has failed and started corroding at the weld seams. This was allowing water to seep in through these holes causing contamination problems for the solution within the tank.

Previous welding had introduced heat activated zones into the tank roof resulting in weakness and corrosion at the weld seams. Welding the tank again would have created the same problems and that's why the Belzona cold applied solution was used.
