Belzona Refurbishes Several Storage Tanks

ID: 8103

Application: TCC-Tanks and Chemical Containment Areas

Refurbishment of the external surfaces of several storage tanks.

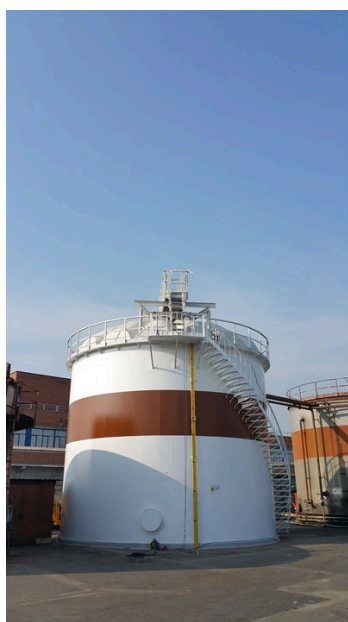
This ecology park had an intervention from the public environmental monitoring authority as they had detected pollution problems. The site did not match environmental standards and required extensive maintenance.

- * 1. First tank before application ,
- * 2. Finished application of first tank ,
- * 3. Overview of other tanks before refurbishment ,
- * 4. Finished application overview of all tanks ,

This application was carried out in accordance with Belzona System Leaflet TCC-05. The external surface of the first storage tank was

grit blasted to Sa 2.5 before applying 2 coats of Belzona 6111 to provide long term corrosion protection, followed by 2 coats of Belzona 5111 for it's UV resistance. After the success of the first tank refurbishment a further 4 tanks were coated within the ecology park following the same procedure as the first.
