Belzona 4341 Internal Lining Protection Against Chemical Attack.

Industry: *Chemical & Petrochemical*
Application: *TCC-Tanks and Chemical Containment Areas*
Substrate: *Steel*
Products: ** Belzona 4341 ,*

Customer Location: *Poland*
Application Date: *2018*

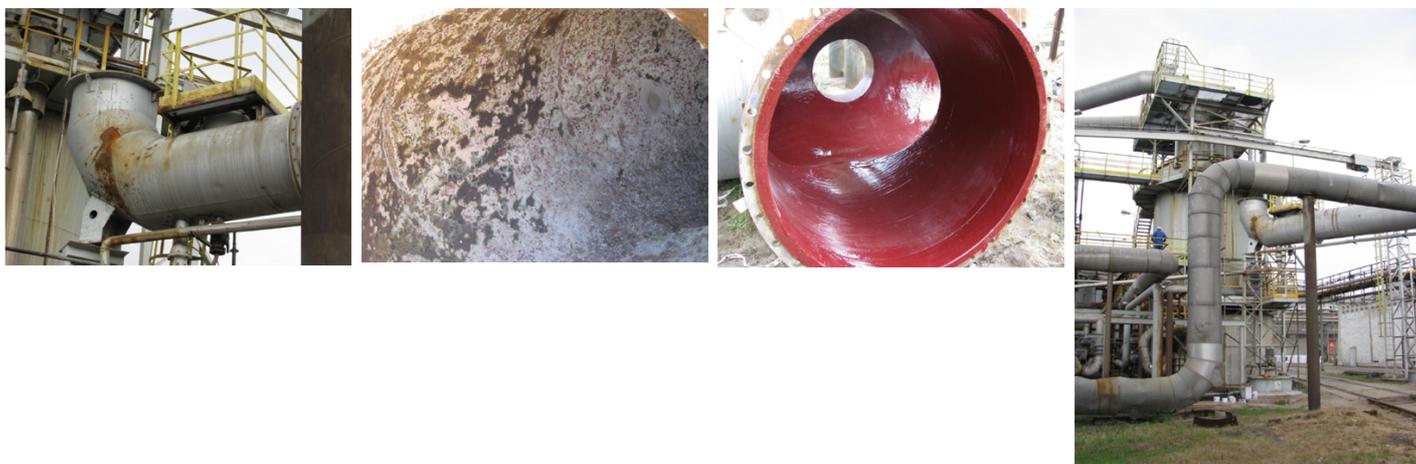
Chemical aggression condensation of hot burns caused the steel to corrode on the pipeline. Which led to perforation of the steel.

- * Picture 1: Visible wall perforation ,
- * Picture 2: Internal surface corrosion ,
- * Picture 3: Belzona coating 4341 ,
- * Picture 4: General view of the installation ,

The application was carried out in accordance with Belzona Know-How Leaflet TCC-03

Belzona 4341 was a proven solution to protect the internal surface lining against chemical attack.
