# Belzona 4341 Internal Lining Protection Against Chemical Attack.

ID: 8105

Industry: *Chemical & Petrochemical*  
Application: *TCC-Tanks and Chemical Containment Areas*  
Substrate: *Steel*  
Products: *\* Belzona 4341 ,*

Customer Location: *Poland*  
Application Date: *2018*

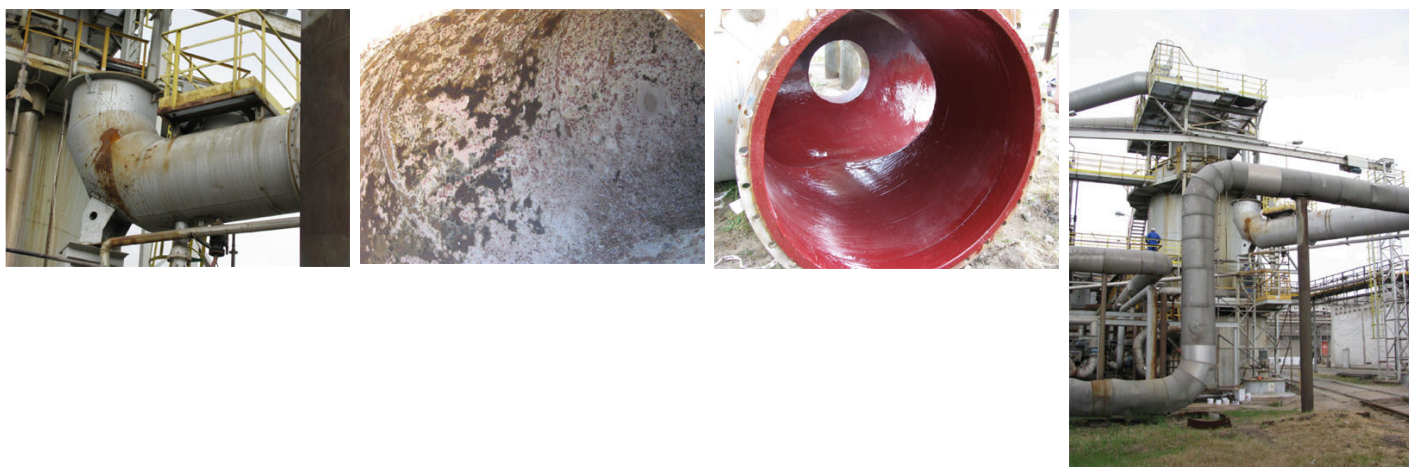
*Chemical aggression condensation of hot burns caused the steel to corrode on the pipeline. Which led to perforation of the steel.*

- \* Picture 1: Visible wall perforation ,
- \* Picture 2: Internal surface corrosion ,
- \* Picture 3: Belzona coating 4341 ,
- \* Picture 4: General view of the installation ,

Phosphoric Plant Works discovered the plant equipment corroding at a fast rate, leading to perforation.

The application was carried out in accordance with Belzona Know-How Leaflet TCC-03

Belzona 4341 was a proven solution to protect the internal surface lining against chemical attack.
