# BELZONA SEAL A TANK APPLICATION ON CRUDE STORAGE TANK AT A REFINERY

ID: 8108

Customer Location: *Refinery, Mumbai, India*  
Application Date: *June 2018*

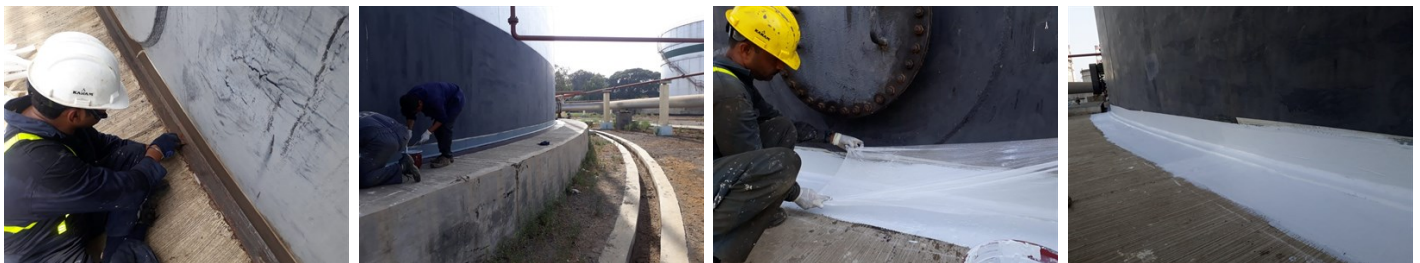
*Water ingresses through the crack between the concrete foundation and tank base. The location of tank is near the sea shore, so presence of high moisture levels accelerates the corrosion at the bottom plate of the tank.*

- \* Surface preparation done on the shell and concrete base of the tank ,
- \* Conditioner applied on the concrete base and the shell of the tank ,
- \* Belzona 3111 along with Belzona 9311 was applied on the prepared surface of the tank ,
- \* Final layer of Belzona 3111 has been applied and tape is ready for removal ,

Painting was removed from the shell upto a height of 0.2 meter from the base. The concrete was also cleaned and the surface was made clean dry and rough. Belzona 3911 (PSC) was applied on the concrete surface, Belzona 3921 ( GSC) was applied on the cleaned metallic surface of the tank. Belzona 3111 was applied on the prepared surface. Belzona 9611 along with Belzona 3111 was applied. After the application gets cured, a final layer of Belzona 3111 was applied.
