BELZONA REBUILDS LARGE MOTOR BEARING HOUSING

Industry: *Power*
Application: *MPT-Mechanical Power Transmission*

Customer Location: *Power station - Egypt*
Application Date: *November 2005*

Substrate: *Steel*
Products: *Belzona® 1111 (Super Metal)*

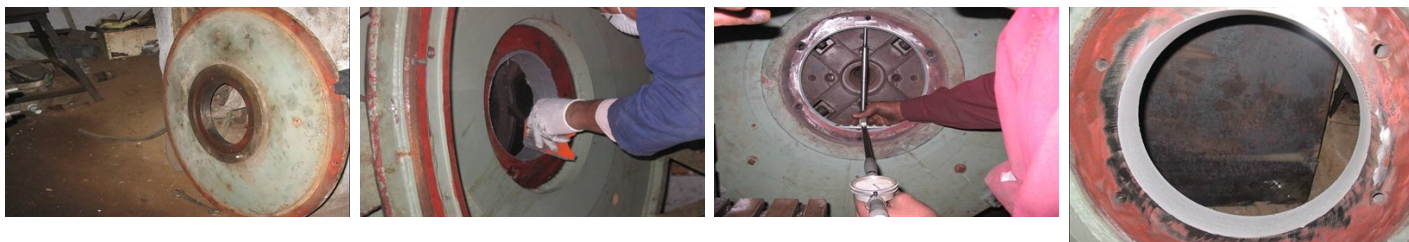
Photograph Descriptions

Bearing housing damaged due to mechanical failure.

* General view of the worn bearing housing , * Applying Belzona® 1111 to rebuild the housing , * Checking the dimensions after machining , * Application completed ,

Application was carried out in accordance with Belzona Know-How System Leaflet MPT-6.

Belzona solved the problem simply without the need for welding or any heat so avoiding distortion.
