BELZONA REBUILDS LARGE MOTOR BEARING HOUSING

ID: 811

Customer Location: Power station - Egypt
Application Date: November 2005

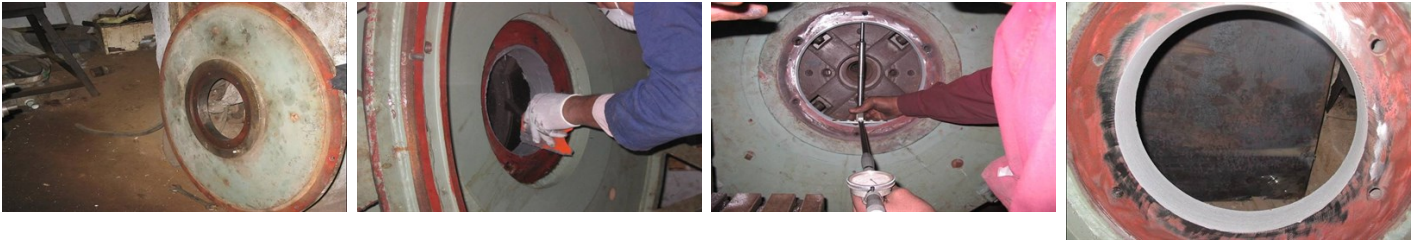
Photograph Descriptions

Bearing housing damaged due to mechanical failure.

* General view of the worn bearing housing , * Applying Belzona® 1111 to rebuild the housing , * Checking the dimensions after machining , * Application completed ,

Application was carried out in accordance with Belzona Know-How System Leaflet MPT-6.

Belzona solved the problem simply without the need for welding or any heat so avoiding distortion.
