# Hot Ore no problem for Belzona

ID: 8112

Application: VPF-Valves, Pipes and Fittings

Customer Location: Aluminium Plant - Spain

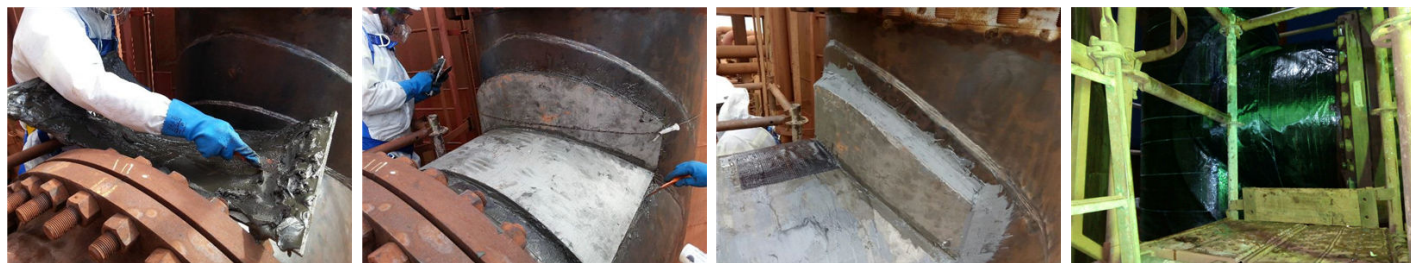
The hot ore is highly abrasive, causing a loss of wall thickness in some areas of the T-section. Further degradation would result in catastrophic failure of the equipment and a forced shut down. Replacement is not an option as this would also require shut down.

- \* Belzona 1251 (HA-Metal) being applied to reinforcement plate ,
- \* Reinforcement plate bonded into place ,
- \* Belzona 1511 used to create a fillet around the plate ,
- \* Completed repair after wrapping with Belzona SuperWrap II ,

The application was carried in accordance a modified version of Belzona System Leaflet VPF-11. A carbon steel reinforcement plate was pre-fabricated to fit the worn area of the pipe section. Preparation was carried out by grit blasting to achieve a near white metal finish and a surface profile depth greater than 75 microns. The reinforcement plate was bonded using Belzona 1251 (HA-Metal) to bond onto the hot substrate whilst in service. The edges were sealed and finished with Belzona 1511 to create a

smooth surface for the Belzona SuperWrap II system to be applied over. Belzona SuperWrap II with Belzona 1983 resin was used to encapsulate the area, adding further strength to the overall system.
