# WATERPROOFING COVERED LABORATORY BUILDING WITH BELZONA SYSTEM 3111

ID: 8113

Customer Location: *Coal Thermal Center in AS Pontes-Galicia*

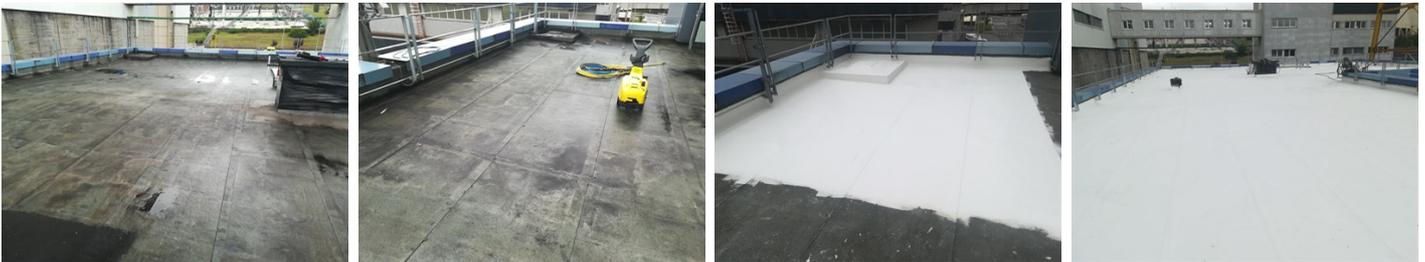
*The deterioration of the asphalt lining in some areas were applied on the concrete roof of the laboratory roof, facilitated the entry of water into the offices and test offices, spoiling highly expensive measuring and testing equipment.*

- \* 1 - START STATUS ,
- \* 2 - CLEANING ,
- \* 3 - APPLICATION BELZONA 3111 ,
- \* 4 - FINAL STATE WITH SECOND LAYER OF BELZONA 3111 ,

The application was completed in accordance with Belzona System Leaflet RPA-6 and TCC-4.

The asphalt roof 600 m2 was repaired with Belzona 3111 after repairing with Belzona 2211.
