Shopping centre step with Belzona grip system

ID: 8128

Application: FPA-Floor Problem Areas

Customer Location: Paisley, Scotland

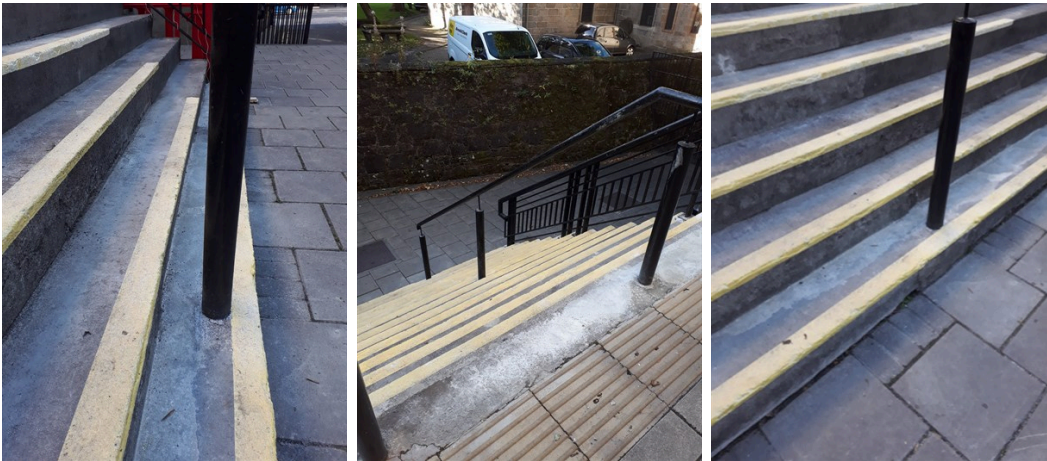
Photograph Descriptions

- * Close up of application ,
- * Top down view ,
- * Bottom view ,

A set of stone steps leading to the entrance of a shopping centre was identified as a potential slip hazard in wet or icy conditions. A hard wearing, easy to see grip system was required to give positive traction to pedestrians using the steps.

The step nosings were abraded with a floor grinder. The Belzona 4411 system was then applied by brush before the Belzona 9221 was sprinkled on top to form the grip system
