# Belzona Repairs To Protect Tank Supports

Customer Location: *Steel Production Site, Lincolnshire, UK*  
Application Date: *October 2019*

Diesel storage tank showing signs of corrosion.

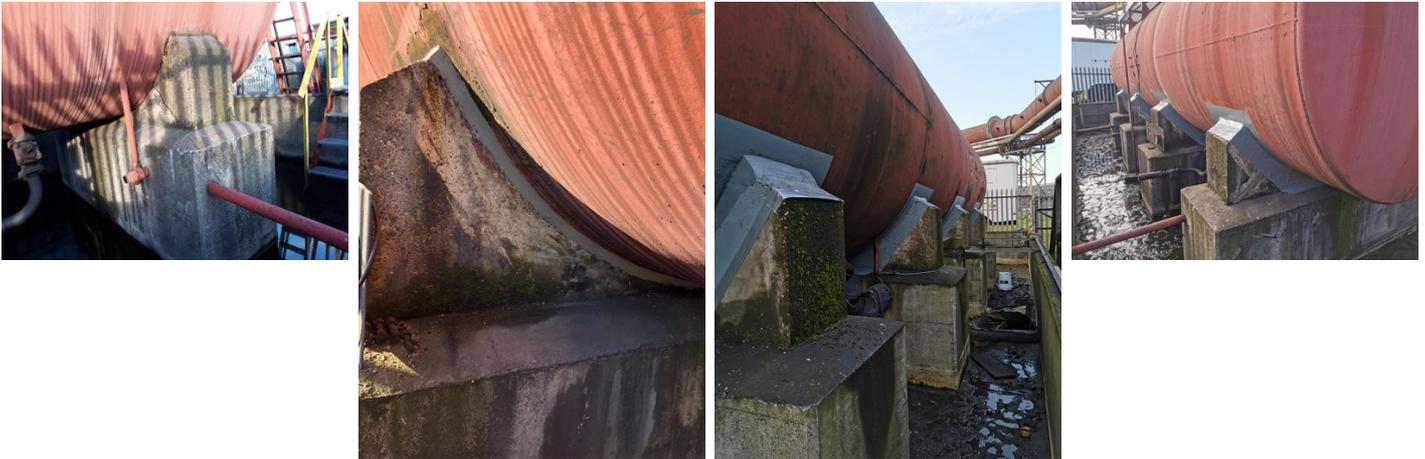
*The tank and concrete saddles were showing some minor signs of corrosion at the joints. This was caused by standing water in these areas. The damage to the tank coating and concrete were only minimal, however if they were not repaired, the damage would have continued to deteriorate causing potential failure of the tank or the supports in the future.*

- \* Area of concern ,
- \* Belzona concrete rebuild completed ,
- \* Conditioner applied ,
- \* Completed repair to tank supports ,

The failed concrete on the tank support was removed using hand tools. The repair area was then prepared to remove any remaining loose particles and dirt from the concrete areas. The concrete was then conditioned and rebuilt to match the surrounding concrete supports using Belzona 4131. Surface preparation of a 100mm band on the concrete and the tank was then undertaken, again using hand tools to remove any failing coating and rust. A two coat, reinforced system of Belzona 3131 was then used to create a seal between the tank and the concrete. A band of 200mm around the tank was applied to concrete interfaces.
