# Belzona Provides Unconventional Tank Base Sealing

ID: 8131

**Customer Location:** Chemical Company, Warrington  
**Application Date:** October 2019

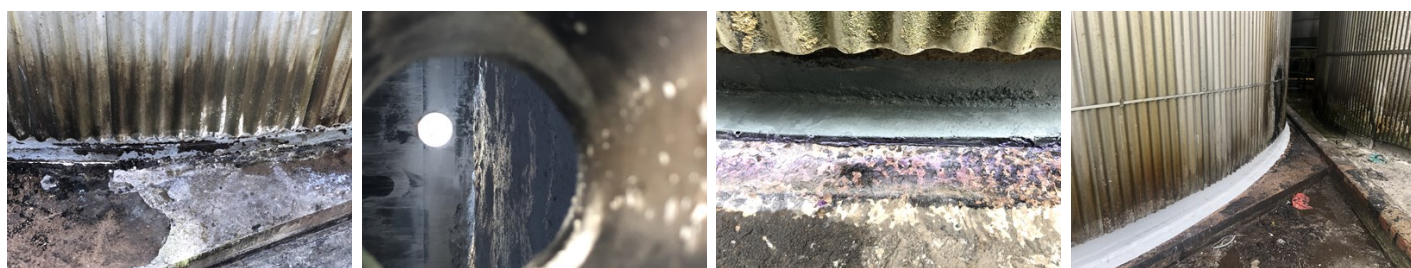
The problem was leakage of product under the base plate in trickles suggesting there is a pinhole in the steel annular plate. It was nearly impossible to remove the hardened product and consequently the location of the pinhole is impossible to locate.

- \* 1. Showing annular plate / concrete plinth leakage and corrosion ,
- \* 2. Shows solidified product in the base of the tank ,
- \* 3. Application of conditioners ,
- \* 4. Completed application ,

The steel annular plate was abraded manually to give a rough finish, and the concrete receive the same treatment to remove any debris and contamination. Belzona 2911 was applied between the base plate and plinth and allowed to dry. Belzona 2211 was applied into the gap to provide a seal and prevent further product leakage. Belzona 3921 and Belzona 3931 were applied to condition the annular plate, followed by two coats of Belzona 3131 to finish. The application was completed in accordance with Belzona System Leaflet GSS-3.
