# BELZONA REDUCES DREDGING PUMP REFURBISHMENT COSTS

Industry: Marine  
Application: CEP-Centrifugal Pumps  
Substrate: Steel  
Products: \* Belzona 1311 (Ceramic R-Metal) ,  
\* Belzona 1814 ,

Customer Location: Dredging Operator, Teesside, UK  
Application Date: October 2019

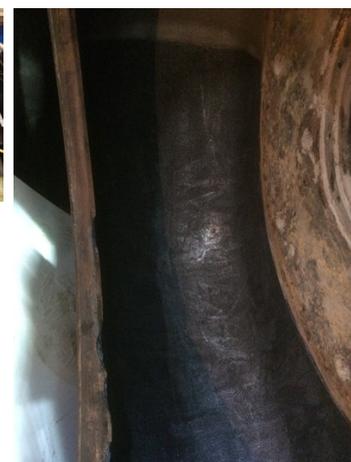
The dredger pump had suffered significant localised damage with several areas requiring repair. The damaged areas extended into nozzles, but the worst attack had been in the belly of the pump.

- \* 1. Hopper Dredger Vessel ,
- \* 2. Initial damage to pump ,
- \* 3. Worst effected area of pump ,
- \* 4. Finished application of Belzona 1814 ,

The application was carried out in accordance with Belzona system leaflets CEP-3 and CEP-5. After treating surfaces with SaltAway to remove soluble salts, the areas were grit blasted and degreased. Belzona 1311 was used to fill localised pitting and to rebuild edges. Finally, the belly of the pump was protected with 3mm of Belzona 1814, which was feathered towards the edges.

Belzona 1814 was chosen as it offered excellent abrasion resistance at a more affordable cost. This new bulk filled abrasion resistant material offered significant savings over the more traditional materials, and costs were nearly halved.
