Structural Reinforcement of Nozzle with Belzona SW II

ID: 8137

Customer Location: *Sao Paulo, Brazil*

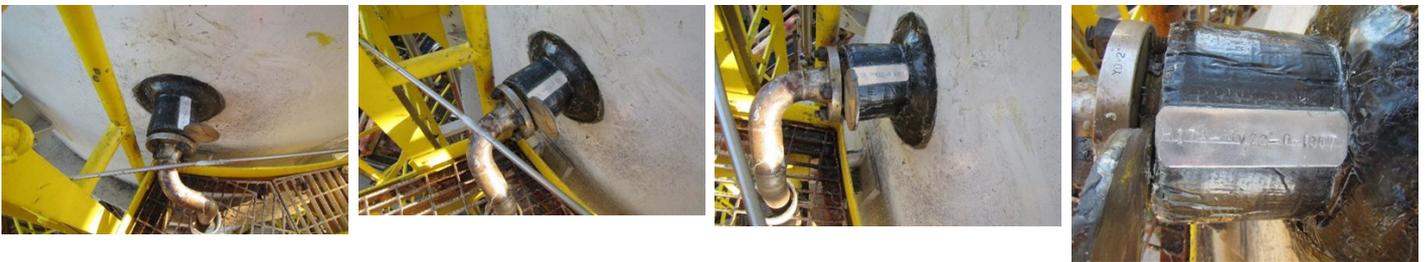
Photograph Descriptions

Nozzle welded to the bottom of the tank showing accelerated signs of internal corrosion. Fluid: Oxygen Scavenger Pressure: 1 kg/cm2 Temperature: 26°C Original Wall Thickness: 8.7mm Final Wall Thickness: 4mm

* 1. Overall view of finished repair 2. Overall view of finished repair 3. Overall view of finished repair 4. Close-up view with metallic id tag ,

Nozzle of process vessel suffering from internal corrosion and significant thickness loss. A carbon fiber polymeric compliant repair was needed, to comply with the structural reinforcement design of the equipment, and allowing for its operational continuity and reliability.

Surface preparation was performed in accordance with SSPC SP11 with a MBX, achieving the required surface roughness for the application. After surface cleaning to get rid of oil and contamination, Belzona 1311 was used to bond a metallic coupler. The Belzona Superwrap II system was then applied around the nozzle and in part of the tank wall, with a final thickness of 6mm.

Application performed on site with certified Belzona applicators in accordance with ASME PCC-2. By restoring the structural integrity of the equipment with a non-metallic repair the end user was able to save on a lot of labor and safety of its employees.
