# Belzona 1111 & Belzona 4311 reconstructs and protects chemical pump

ID: 8140

Industry: Sugar  
Application: CEP-Centrifugal Pumps  
Substrate: Cast Iron  
Products: \* Belzona 1111 (Super-Metal) ,  
\* Belzona 9111 (Degreaser) ,  
\* Belzona 4311 (Magma CR1) ,  
\* Belzona Flange Face Forming Kit. ,

KSB centrifugal pump which is used for pumping chemicals, in a sugar factory.

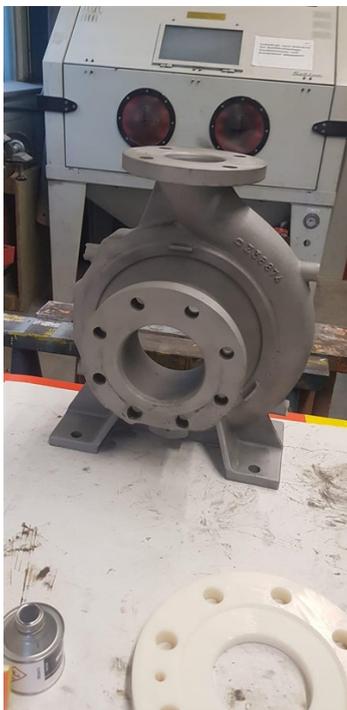
The chemicals attacked or completely destroyed the flange surfaces and parts of the housing.

- \* Image 1: Damaged Pump ,
- \* Image 2: Flange Reform ,
- \* Image 3: Internal Coating Complete ,
- \* Image 4: Flange Reformed. ,

Re-built with Belzona 1111 with the use of the Flange Face forming kit and then protected with a Belzona 4311 in accordance with Belzona Know-How CEP-03.
