Belzona 1111 & Belzona 4311 reconstructs and protects chemical pump

ID: 8140

Industry: Sugar
Application: CEP-Centrifugal Pumps
Substrate: Cast Iron
Products: * Belzona 1111 (Super-Metal) ,
* Belzona 9111 (Degreaser) ,
* Belzona 4311 (Magma CR1) ,
* Belzona Flange Face Forming Kit. ,

Customer Location: Switzerland
Application Date: 15.11.2019

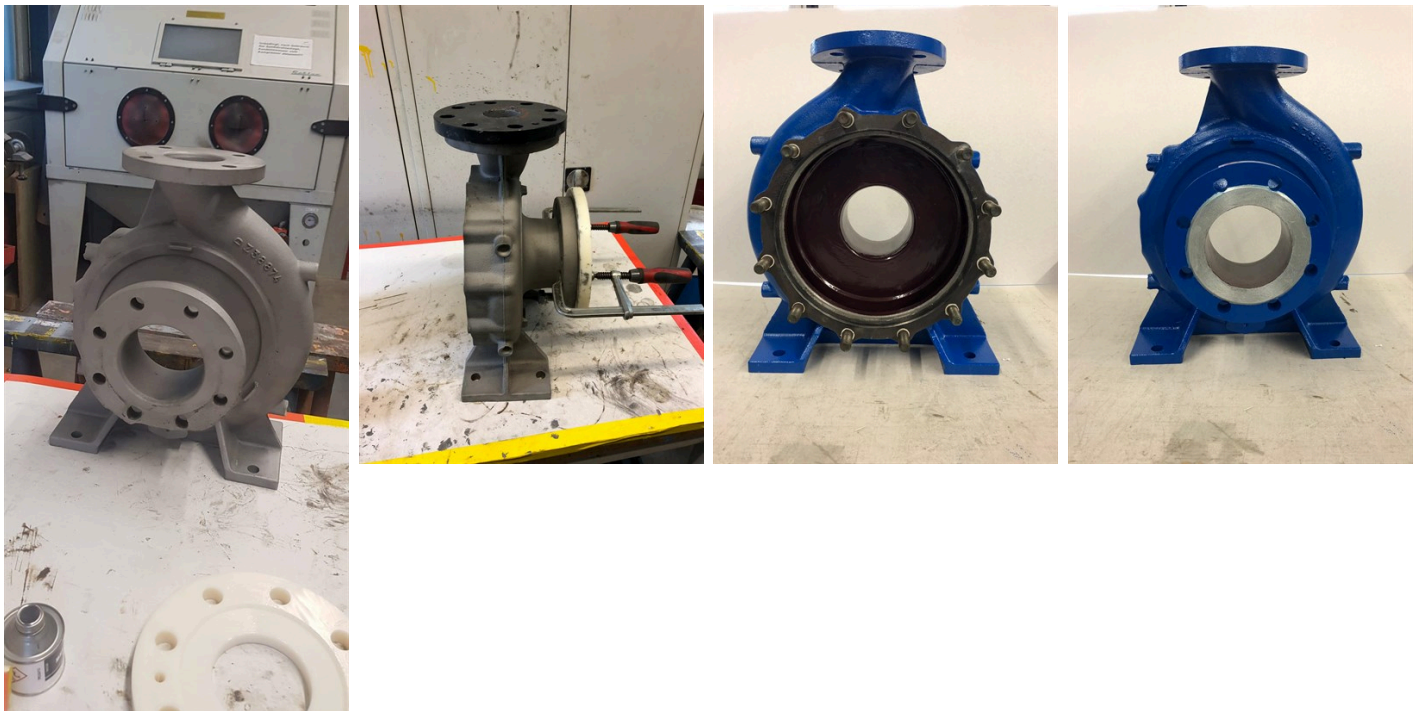
The chemicals attacked or completely destroyed the flange surfaces and parts of the housing.

- * Image 1: Damaged Pump ,
- * Image 2: Flange Reform ,
- * Image 3: Internal Coating Complete ,
- * Image 4: Flange Reformed. ,

Re-built with Belzona 1111 with the use of the Flange Face forming kit and then protected with a Belzona 4311 in accordance with Belzona Know-How CEP-03.
