Belzona Seals Silo Flange

ID: 8141

Customer Location: Power Plant, Liverpool, UK
Application Date: November 2019

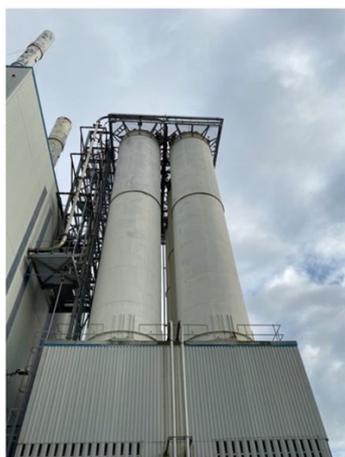
- * 1. Silo showing the suspect flange joint ,
- * 2. Leaking flange joint ,
- * 3. Rope access contractor applying Belzona materials ,
- * 4. Completed application on powder silo ,

Dry powder silo had mastic sealant between flange joints which hardened and shrunk. This resulted in the mastic falling out leaving exposed gaps. The silo is tall and difficult to reach so using a specialist rope access contractor was the best option.

The joint was cleaned out using a grinder making sure the joint upper and lower faces were rough. The flange face where the Belzona Elastomer was to be bonded was also manually prepared, cleaned and degreased prior to the application of Belzona 2911. Belzona 2211 was then applied to seal the flange face against moisture ingress. This application was completed in accordance with a modified version of Belzona System Leaflet GSS-11.
