HIGH SPEED FERRY PROPELLER CAVITATION DAMAGE REPAIR

ID: 8145

Customer Location: *Tuzla, ISTANBUL, TURKEY*
Application Date: *April 2019*

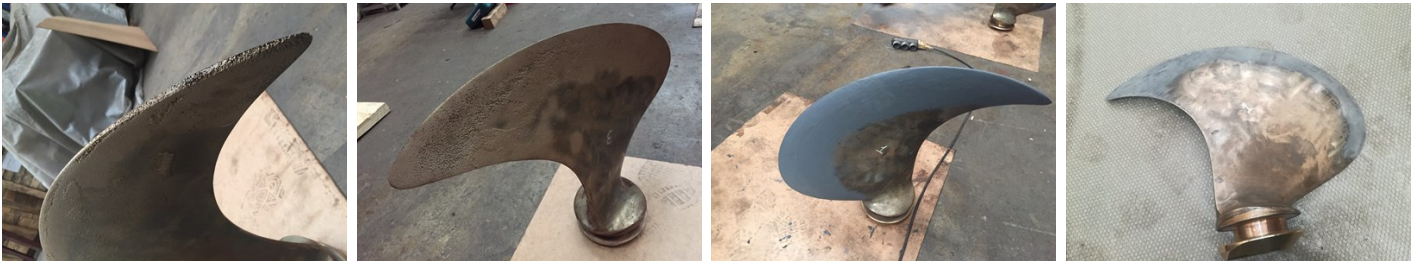
Photograph Descriptions

- * Cavitation damage on the propeller. ,
- * After surface preparation. ,
- * Application Belzona 1311 (Ceramic R-Metal). ,
- * The surface faired after Belzona application. ,

Cavitation damage on both propellers of high speed ferry. The damage is more intense on the blade leading edges. The damaged propellers causing ferry two operate with some vibration and less hydrodynamic efficiency.

Application was carried out in accordance with Belzona Know-How System Leaflet SOS-01. Propeller surface blasted in blasting cabin. Surface was cleaned with Belzona 9111 (Cleaner & Degreaser) after blasting. Immediately following surface preparation Belzona 1311 (Ceramic R-Metal) is applied on the surface. After the product is cured, the surface was grinded and faired to achieve smooth surface.
