Belzona Repairs Light Gauge Conveyor Belt

ID: 8147

Application: *SHM-Solids Handling Machinery*

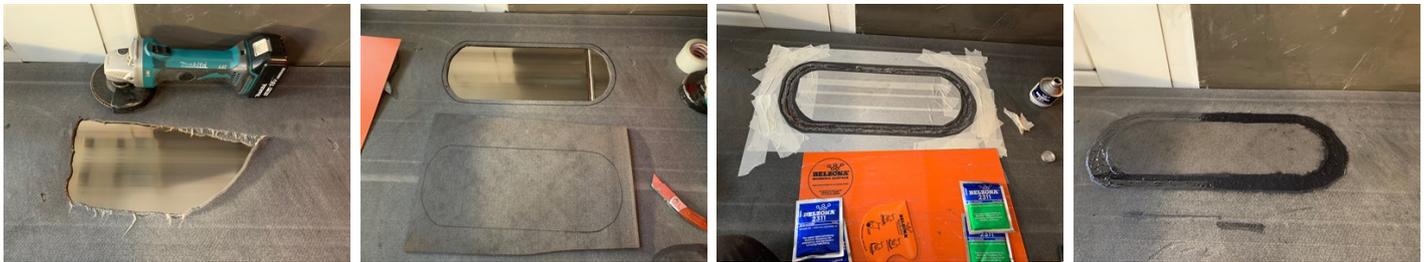
Photograph Descriptions

The large distribution center operate around 300 belts for conveying stock, mainly in plastic tote boxes. The boxes can approach 200Kg and fall through chutes hitting the moving belts. The belts are suffering damage and, at present, the client have no way of repairing the belts, forcing exchange at a cost of around £3,000 per belt.

- * Repair scenario (Power tool shown for scale) ,
- * Patch cut from spare belt ,
- * Masked area and repair being completed using 2311 ,
- * Full repair completed. Repair time around 40 minutes ,

There were two types of belt, one was a thin rubber with a matted reinforced base, the other, a three ply with a central rubber core and two adjacent “felt” type surfaces.

Application was carried out in accordance with a modified version of Belzona System Leaflet SHM-1. Following successful trial applications, the Belzona solution that was selected involved the cutting out of the damaged area. A patch was then created using a spare piece of conveyor belt. The new piece of belt was then bonded in place using Belzona 2311 (SR Elastomer).
