Belzona 4111 stands up to heavy mine traffic

ID: 8149

Application: *FPA-Floor Problem Areas*

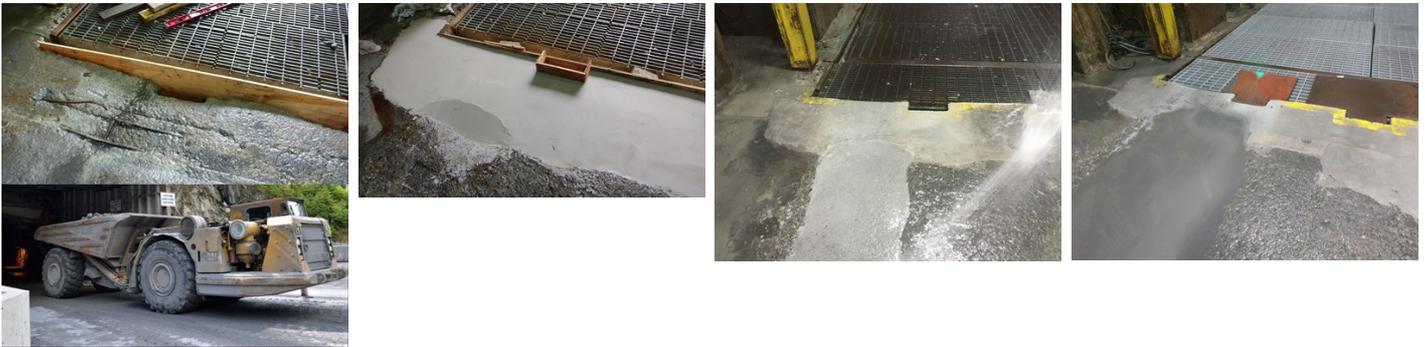
Photograph Descriptions

Extremely deep wear in the concrete floor in the tread areas of this wash bay. Full mine haul trucks roll across this floor year round with cleated tire chains. The deep ruts were being covered with heavy steel plates. Both the ruts and steel plates were causing a hazard to the crew when walking in the area.

- * Original wear and one of the the mining trucks causing the damage ,
- * Belzona 4111 applied May 2016 ,
- * Belzona 4111 in April 2017 ,
- * Belzona 4111 in November 2019 ,

A grinder and wire wheel was used to remove all the loose material from the surface of the area of application. The exposed steel re-bar was prepped with the grinder to remove all rust and corrosion. Belzona 4911 conditioner was then mixed and applied over the area, and immediately following the Belzona 4111 was mixed and applied and finished with a steel trowel. Note that plywood was used as a form. In this situation, aesthetics was not a concern, so no release agent was used. When the ply wood was removed, some of the wood fibers remained stuck to the Belzona 4111, but did not have any impact on the application.

Replacing the floor was not an option as it would require the entire mine to shut down for 28 days while the concrete cured. The mine had a 3 day maintenance shut down planned, and the repair has to be done during this time, and be ready for use at the end of the shut down with no exceptions. Using Belzona 4111 to repair this allowed for the application to be done on the first day of the shut down, and was fully cured and ready for operation 3 days later. Pictures 1 and 3 years later show extremely minimal wear, and should any further repairs be needed, applying more 4111 over the top will also be fast and can be done during a scheduled shut down. The mining operation is now planning on using Belzona 4111 in several other areas of their operation as the material has proven it's suitability for this highly aggressive environment.
