Ferry pipe leak repaired by Belzona

ID: 8152

Industry: *Marine*
Application: *VPF-Valves, Pipes and Fittings*
Substrate: *Steel*
Products: ** Belzona 1161 (Super UW Metal) ,*
** Belzona 9341 Reinforcement tape ,*

Customer Location: *Greenock, Scotland*
Application Date: *September 2019*

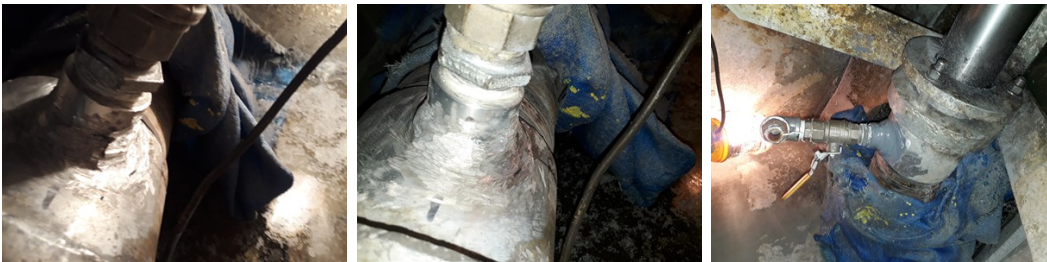
Photograph Descriptions

- * Leaking area ,
- * Area roughened with grinder ,
- * Belzona 1161 applied ,

A leak was found on a pipe section during docking. A temporary repair was required to stop this leak before long term repairs could be carried out.

Removal of the pipe & replacement part coming would have taken around a week, an unacceptable delay to the customer. Welding was deemed to hazardous due to the water in the area.

The area was prepared by roughening with a hand grinder. Belzona 1161 was the applied around the circumference of the pipe, Belzona 9341 was incorporated into the repair. Heat was then applied to 'force cure' the product.

By utilising the Belzona repair method the ferry was able to sail later that day
