# Belzona Protects Tank Roof against Sulphur Fumes

ID: 8154

Industry: Oil & Gas  
Application: TCC-Tanks and Chemical Containment Areas  
Substrate: Steel  
Products: \* Belzona 1511 (Super HT-Metal),  
\* Belzona 1593 ,

Customer Location: Slovakia  
Application Date: 2019

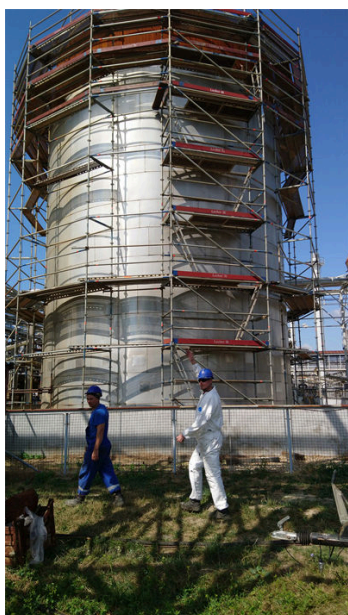
A build-up of condensation from the 100% liquid Sulphur had caused the tank roof to pit and corrode.

- \* 1.) Outside view of the Sulphur tank ,
- \* 2.) Corroded tank roof ,
- \* 3.) 2 coat system of Belzona 1593 applied to the roof ,
- \* 4.) View of the tank roof from the bottom ,

This application was carried out in accordance with Belzona system leaflet TCC-05. The tank roof was cleaned and then grit blasted to SA 2.5, achieving a 75 micron profile to provide an excellent level of adhesion to the substrate. Once grit blasted, any pits were

filled in with Belzona 1511 before 2 coats of Belzona 1593 were applied to the tank roof.
