# BELZONA REPAIR AND PROTECTS PROPELLER SHAFTS

ID: 8156

Customer Location: *Ro-Ro Vessel Operator, ISTANBUL, TURKEY*

Ro-Ro Ship propeller shaft.

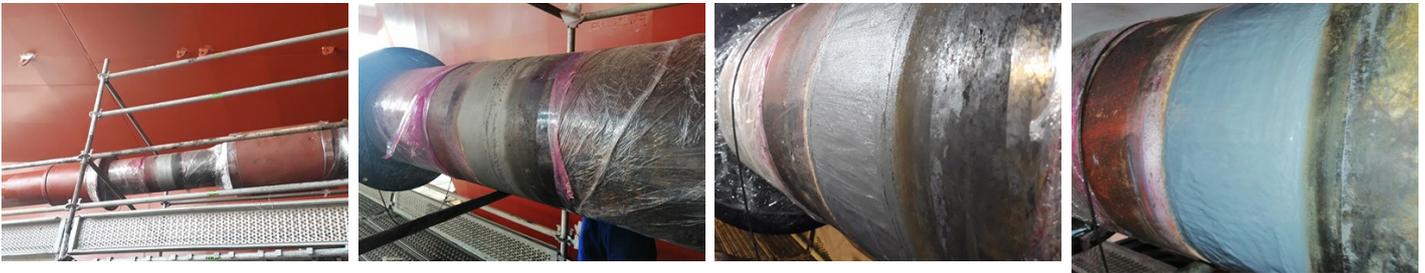
*Cavitation damage on the propeller shaft.*

- \* Cavitation damage on the propeller shaft. ,
- \* After surface preparation. ,
- \* Repair with Belzona 1311. ,
- \* Coating application with Belzona 1321. ,

Application was carried out in accordance with Belzona Know-How System Leaflet SOS-01 and SOS-02. Shaft surface was prepared with SA 2,5 grit blasting. Surface then cleaned with Belzona 9111. Belzona 1311 was used to repair the damaged shaft surface. Belzona 1321 was applied to on top of Belzona 1311 within the overcoating window, without the need of additional surface preparation.

Propeller shaft replacement would be very costly time consuming. Welding and machining at workshop requires the removal of the shaft which is time consuming and costly. In-situ repair with Belzona is low cost solution and saves time. The great advantage of Belzona 1321 is that it can be applied within a few hours on top of Belzona 1311 application. Belzona 1321 was used to achieve protection against cavitation.
