Belzona Products repair and waterproof Wind Turbine Base

ID: 8158

Customer Location: Texas
Application Date: Sep 2019

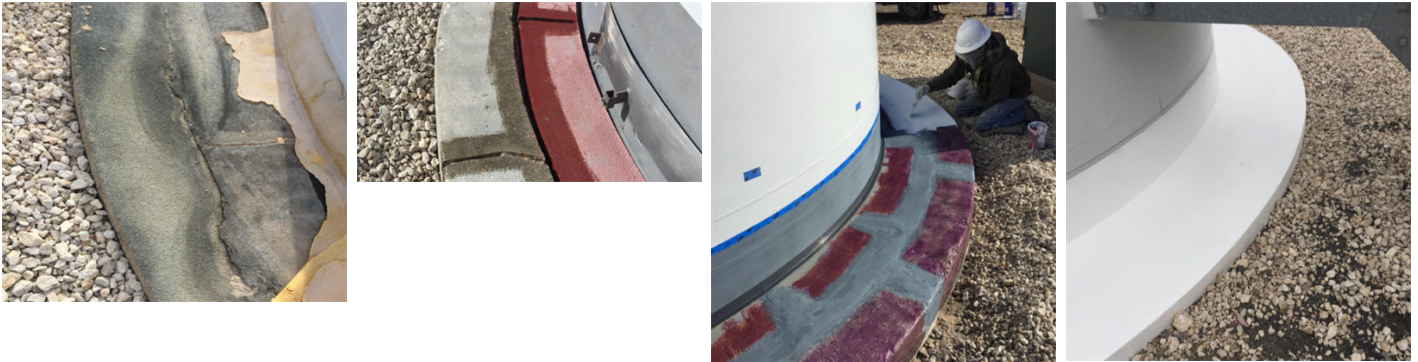
Photograph Descriptions

After years of service the interface between the wind turbine tower and the concrete base deteriorated because of water ingress and freeze-thaw. An unknown product was used as a repair but never bonded correctly to the concrete and cracked along with the old concrete. Also the sealant in the expansion joint failed in the area between the tower base and the concrete and the gap had gotten very wide. Water was ingressing into the tower base structure itself. The tower itself was vibrating during operation because of the gaps and crack around it.

- * 1. Damaged concrete base with coating peeling. ,
- * 2. Damaged concrete base seeing old grout not bonded to the old concrete. ,
- * 3. 4131/4911 bonding the old concrete and old grout forming a new circular base. The 4511 expansion joint product applied in the interface. 3111 being applied around the finished base. ,
- * 4. The whole base up to the metal structure completely weatherproofed with 3111. ,

Took all loose concrete and old loose grout out. The perimeter area of the tower was grouted with Belzona 4131. Belzona 4131 was used to make a new circular base around the interface. Belzona 4511 was then used in the interface area as the expansion joint

sealant between the concrete and the metal. Finally the whole tower base was waterproofed up to the metal with Belzona 3111.
