Abrasion Protection of Linatex Tower

Industry: General Industry
Application: SHM-Solids Handling Machinery

Customer Location: Quarry, Scotland UK
Application Date: 2019

Substrate: Steel
Products: * Belzona 1321 (Ceramic S-Metal) ,
* Belzona 1812 (Ceramic Carbide FP) ,
* Belzona 9811 ,

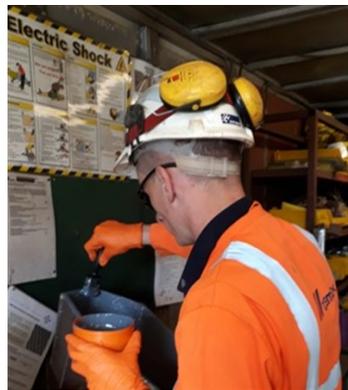
The abrasive qualities of sand had resulted in wear and holes on the steel chute. The equipment only lasted six months before wearing out, so a more permanent solution was required by the client.

- * Equipment prior to coating ,
- * Application of Belzona 1321 ,
- * Tiles grouted in-place ,
- * Completed application after six months in service ,

Sand drops into the entrance of the chute causing excessive wear.

Belzona 1321 was used as an adhesive for the Belzona 9811 Alumina tiles. They were then grouted in with Belzona 1812. As not to

waste the left of material, Belzona 1812 was then applied over the tiles. The application was carried out in accordance with Belzona System Leaflet SHM-7.

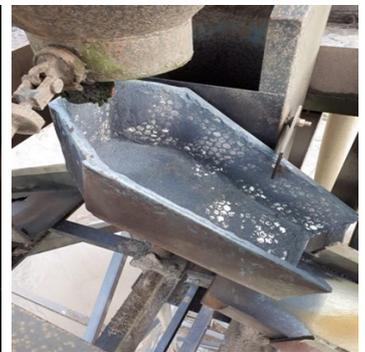
The service life of this part is normally six months. Fabrication of a new chute cost around £500, plus a day lost for production every 6 months. The cost of the Belzona repair was 25% less and is still showing no signs of deterioration.
