Belzona apply Internal Lining to Heat Exchanger Shell

Industry: Oil & Gas
Application: HEX-Heat Exchangers
Substrate: Steel
Products: * Belzona 1511 (Super HT-Metal) ,
* Belzona 1593 ,

Customer Location: Oil refinery, North West England
Application Date: February 2019

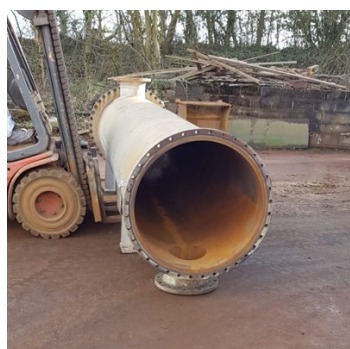
- * Equipment delivered to Belzona Technosol workshop ,
- * Extent of the damage ,
- * First coat of Belzona 1593 ,
- * Second coat Belzona 1593 ,

The heat exchanger was dismantled and delivered to the Belzona workshop in to two parts - the main shell and the dome end. The internal substrate was grit blasted in our workshop under controlled conditions. The pitted steel within the shell was then repaired using Belzona 1511. Following this two Belzona 1511 Nozzle Inserts were bonded into both drain and vent nozzles on the cap end, guaranteeing total encapsulation within these areas. Following the repair, two coats of Belzona 1593 were applied to provide long-term protection. Completed in accordance with Belzona System Leaflet HEX-03

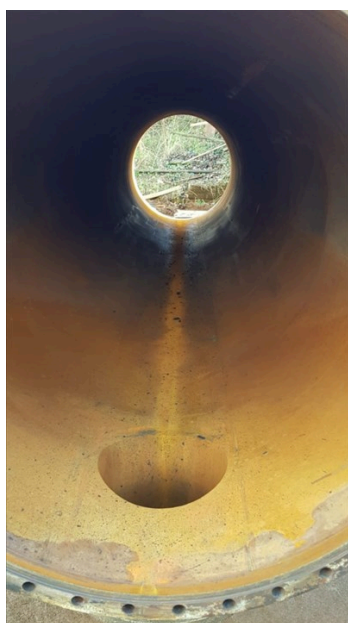
Internal corrosion to the internals of a heat exchanger

The client had a heat exchanger which was suffering from internal corrosion. They required a solution to repair the internal damage and then apply a suitable internal lining to protect the shell from further damage and extended the equipment's life span.
