Belzona renovate a process tank

ID: 8169

Internal lining of a wheat starch milk tank in a factory

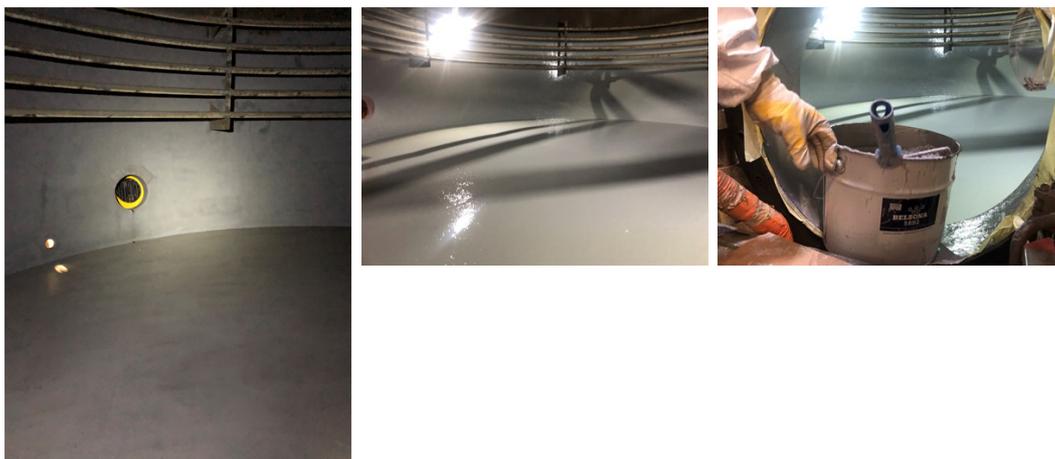
Photograph Descriptions

The internal lining of the tank was corroded due to the products being acidic when they are at high temperatures.

* 1 - Tank after grit blasting 2 - During application of Belzona 5892 3 - Tank after complete coating ,

Application was carried out in accordance with Belzona System Leaflet TCC-5. The tank was previously grit blasted to remove the rust before applying 2 coats of Belzona 5892. Small retouches were made before the coating system was post-cured with steam.
