Belzona Coats 2 x Pemo Pumps

ID: 8178

Application: CEP-Centrifugal Pumps

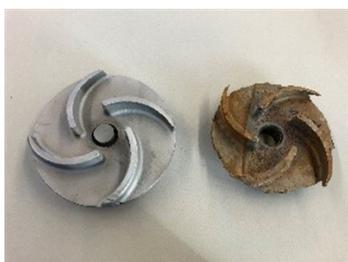
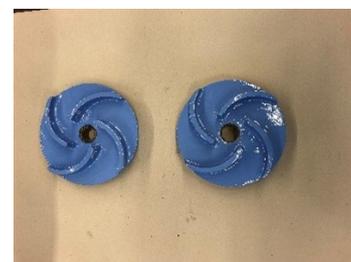
Due to the sand in the water, it damaged the pumps within a short time (6 months). As a result, the pumps were only giving an output pressure of 6 bar of 12 bar. The pumps lost power and the company's production slowed. By slowing down production, the customer made losses every day.

- * Pemo pumps in the service center. Additional blasting work to better inspect the pumps. Image ,
- * After blasting, a mold was made for the re-profiling of the impellers with Belzona 1111. Additional construction of the housing passage with Belzona 1111. ,
- * After re-profiling, the parts were turned to size on the lathe. ,
- * In addition, the parts were coated with Belzona 1321 Grey and Belzona 1341 Blue. ,

2-stage Pemo pump with heavy leaching.

All components of the Pemo Pumps were previously grit blasted according to SA 2½ / 75µ. After grit blasting, the components were immediately re-profiled with Belzona 1111 and Belzona 9341. This process was repeated several times to achieve the original size. After re-profiling, the parts were turned to the original size on the lathe. After the re-profiling was completed, the pumps would be coated with Belzona 1321 Grey and Belzona 1341 Blue. Application was carried out in accordance with Belzona Know-How system
