BELZONA SAVES FISHING BOAT TAILSHAFT

ID: 818

Industry: *Marine*
Application: *MPT-Mechanical Power Transmission*

Customer Location: *Fishing Company, Philippines*
Application Date: *June 2006*

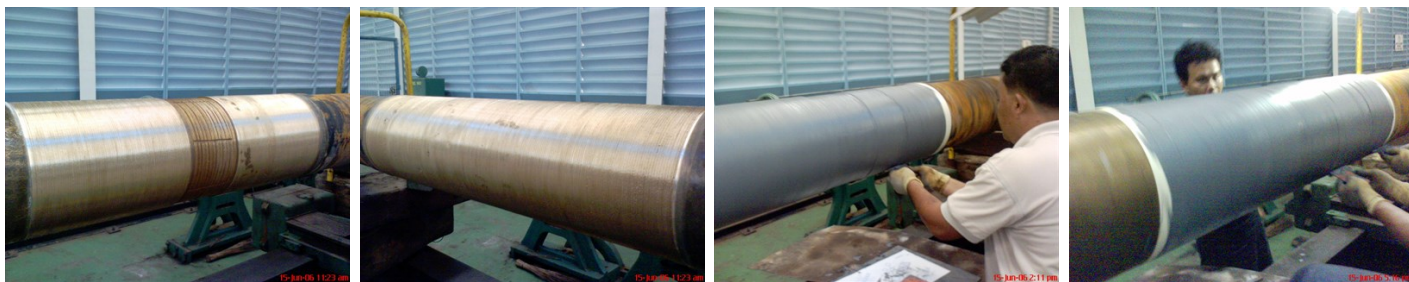
Photograph Descriptions

Severely worn bushing on the propeller shaft damaged the cutlass bearing causing vibration on the fishing vessel.

* Worn bronze bushing , * Surface preparation using machining technique , * Application of Belzona® 1111 , * Application of Belzona® 1111 being completed ,

Worn Propeller Shaft Bushing

Repair was carried out in accordance with Belzona Know-How System Leaflet MPT-1

Replacement with new bronze sleeves would be very costly and too time consuming.
