# BELZONA SAVES FISHING BOAT TAILSHAFT

Industry: *Marine*  
Application: *MPT-Mechanical Power Transmission*

Customer Location: *Fishing Company, Philippines*  
Application Date: *June 2006*

Substrate: *Bronze*  
Products: *Belzona® 1111 (Super Metal)*

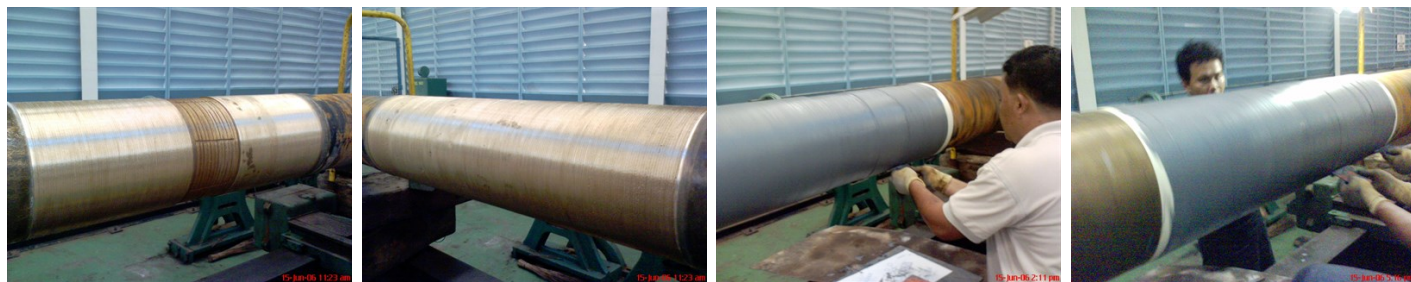
## Photograph Descriptions

*Severely worn bushing on the propeller shaft damaged the cutlass bearing causing vibration on the fishing vessel.*

\* Worn bronze bushing , \* Surface preparation using machining technique , \* Application of Belzona® 1111 , \* Application of Belzona® 1111 being completed ,

Worn Propeller Shaft Bushing

Repair was carried out in accordance with Belzona Know-How System Leaflet MPT-1

Replacement with new bronze sleeves would be very costly and too time consuming.
