# Belzona repairs a thruster

ID: 8184

Industry: *Marine*  
Application: *SOS-Ships and Offshore Structures*

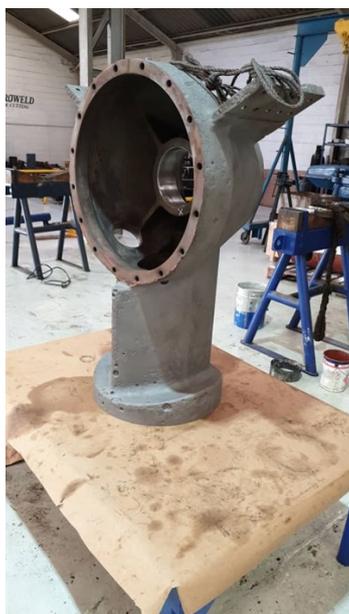
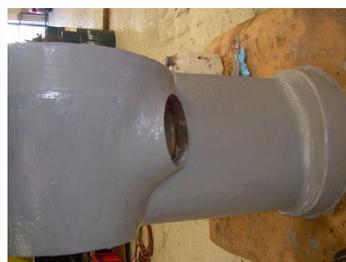
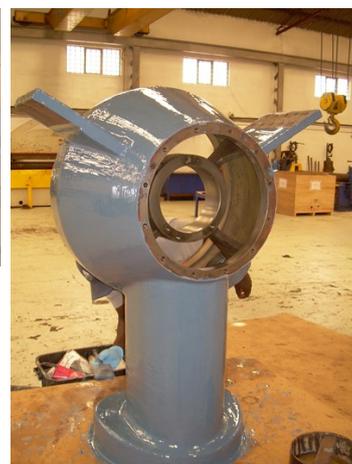
\* 1. Pitted Housing 2. After grid blast 3. after applying Belzona 1111 4. Final coat Belzona 1321 ,

*Heavily pitted and corroded on the out side of the thruster housing which would be costly and time-consuming to repair.*

Stern Thruster for sea going vessel has a large degree of pitting due to erosion-corrosion by sea water.

Application was carried out according to the KHIA Leaflet SOS-1.

This is very costly to replace and also to weld up and grind down to size. Belzona is a very cost effective way to repair and protect.
