Belzona repairs a thruster

ID: 8184

Industry: *Marine*
Application: *SOS-Ships and Offshore Structures*

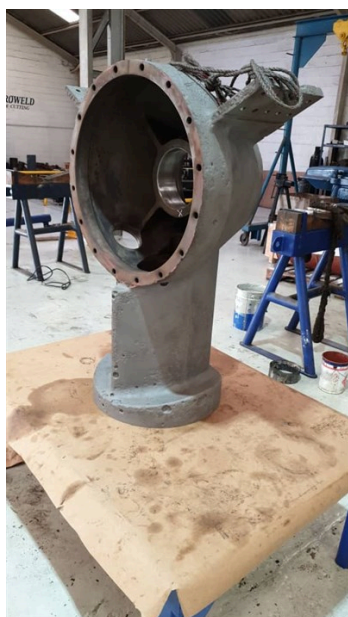
Heavily pitted and corroded on the out side of the thruster housing which would be costly and time-consuming to repair.

* 1. Pitted Housing 2. After grid blast 3. after applying Belzona 1111 4. Final coat Belzona 1321 ,

Stern Thruster for sea going vessel has a large degree of pitting due to erosion-corrosion by sea water.

Application was carried out according to the KHIA Leaflet SOS-1.
