# Belzona repairs a thruster

ID: 8184

Industry: Marine  
Application: SOS-Ships and Offshore Structures

Customer Location: Namibia  
Application Date: 2020-03-04

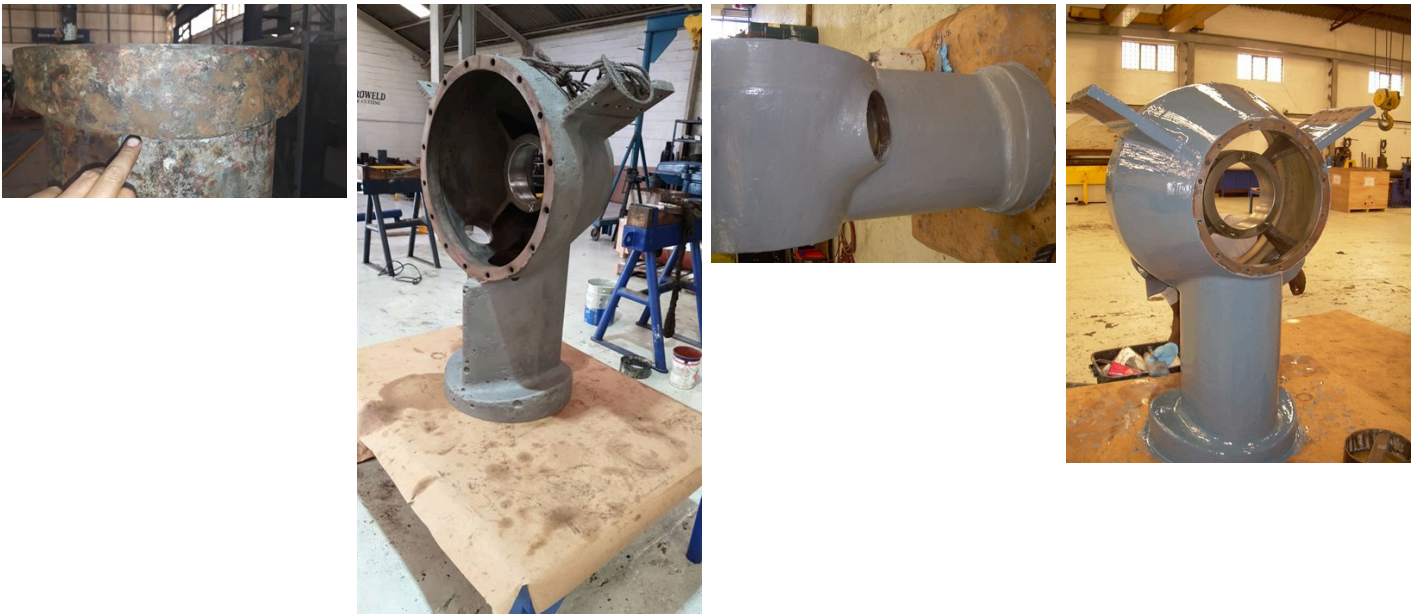
Heavily pitted and corroded on the out side of the thruster housing which would be costly and time-consuming to repair.

\* 1. Pitted Housing 2. After grid blast 3. after applying Belzona 1111 4. Final coat Belzona 1321 ,

Stern Thruster for sea going vessel has a large degree of pitting due to erosion-corrosion by sea water.

Application was carried out according to the KHIA Leaflet SOS-1.

This is very costly to replace and also to weld up and grind down to size. Belzona is a very cost effective way to repair and protect.
