BELZONA SEALS FUEL TRANSPORT HOSE 66FT UNDERWATER

ID: 819

Industry: Marine
Application: SOS-Ships and Offshore Structures

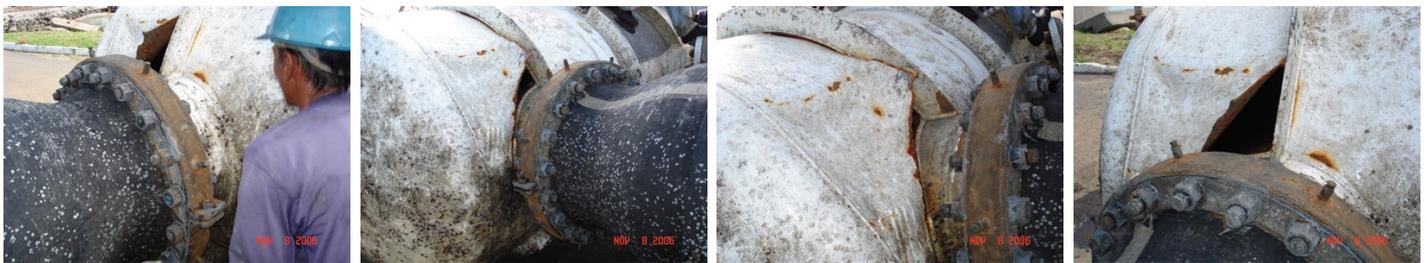
Photograph Descriptions

Accident caused leaks on the flange and bolt areas of the fuel transport hose. This posed a severe environmental hazard necessitating immediate action.

- * -4. The Flange brought on-shore. Note the clamp around flange circumference. ,

The application was carried out in accordance with Belzona Know-How System Leaflet SOS-20. A team of 15 divers sealed individual bolts whilst a clamp was sealed around the flange circumference using Belzona® 1161.

Belzona® 1161 provided the divers with a material that could stem the leak underwater averting a major environmental incident. The excellent adhesion and ease of use of the Belzona® 1161 underwater allowed effective repairs to be carried out, allowing oil transfer to be completed before recovering the hose for more permanent repair ashore
