BELZONA SEALS OPEN DRAIN

ID: 820

Customer Location: Chemical Manufacturer (Chromium)-UK
Application Date: July 2006

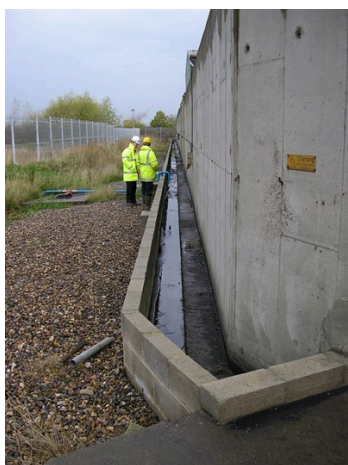
Under heavy rain the drain leaks through the concrete base/block interface & through the porous blocks themselves.

- * General view of open drain ,
- * Belzona® 5811, first coat ,
- * Belzona® 5811, second coat ,
- * The completed application ,
