Paper & Pulp Plant tank repaired with Belzona 5892

ID: 8203

Application: *TCC-Tanks and Chemical Containment Areas*

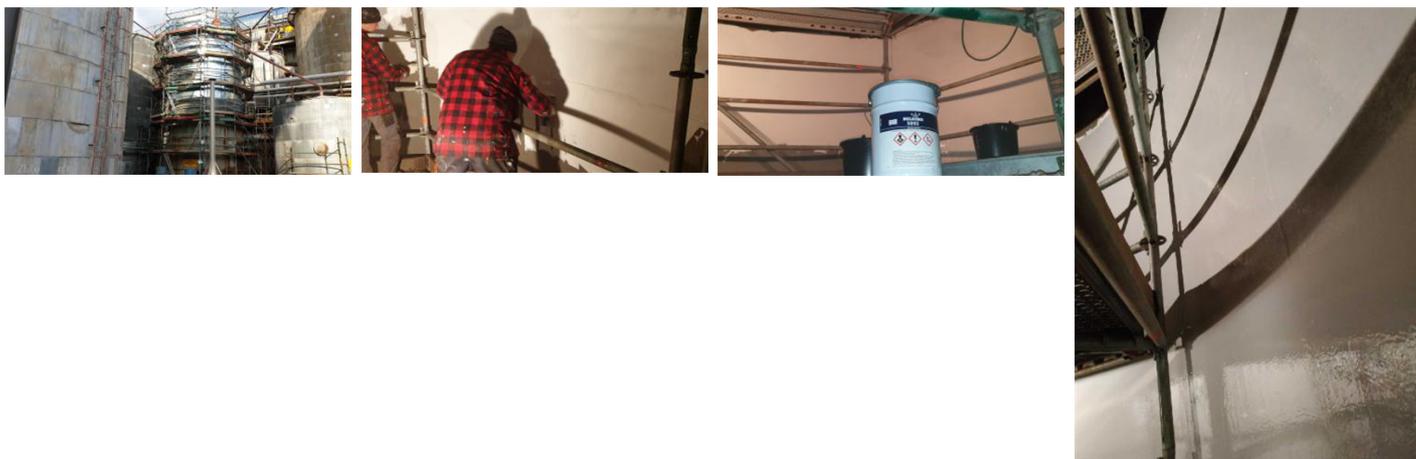
Photograph Descriptions

Internal of the condensate tank at the paper & pulp plant was suffering from corrosion.

* Condensation Tank Application of Belzona 5892 Belzona 5892 2nd layer Application Complete ,

Condensate tank suffering from corrosion.

Substrate grit blasted to surface cleanliness (Sa21/2). Followed a profile check for the min surface roughness of 75 microns. Degreasing surfaces with Belzona degreaser 9121 and applied Belzona 5892 in a two coat system. The application was completed in accordance with Belzona System Leaflet TCC-05.
