BELZONA SOLVES HOLED TANK & HANDRAIL PROBLEM

ID: 821

Industry: *Chemical & Petrochemical*
Application: *TCC-Tanks and Chemical Containment Areas*
Substrate: *Steel*
Products: *Belzona® 1111 (Super-Metal)*

Customer Location: *Chemical Manufacturer (Chromium), UK*
Application Date: *May 2005*

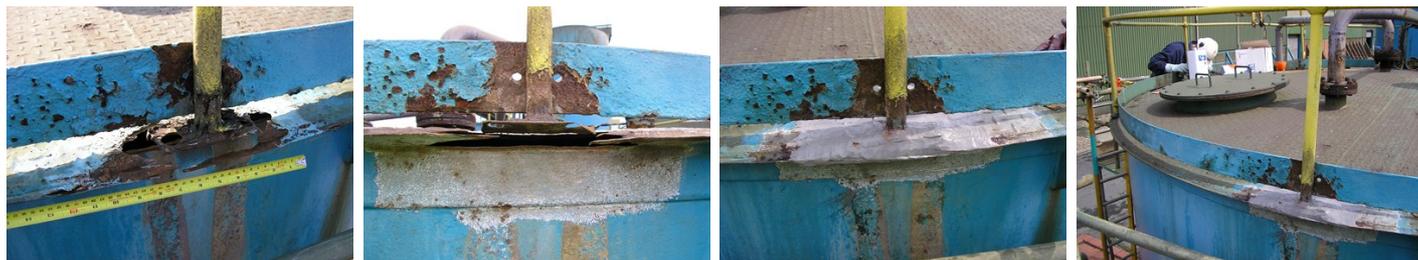
General corrosion on this old chemical tank had left a hole at the top under a handrail support.

* View of corroded area. , * Surface preparation ongoing. , * Rebuilding with Belzona® 1111. , * The completed repair. ,

Holed chemical tank & corroded handrail support.

The application was carried out in accordance with a modified version of Belzona Know-How System Leaflet TCC-5. After a preparation involving needle-gunning & abrading a support plate was bonded onto the underside of the repair area using Belzona® 1111. Once this had cured the whole area was then rebuilt using Belzona® 1111 incorporating reinforcing sheet.

No hot work was allowed when the tank was in use so the customer originally wanted the repair to last to the next shutdown in 9 months at which time they planned to carry out a fabrication repair. After inspection during the shutdown they decided the Belzona repair was sound & a fabricated repair was not necessary.
