# BELZONA TANK BASE SEALING PREVENTS STRESS CORROSION CRACKING

ID: 823

Stainless steel storage tank base seal

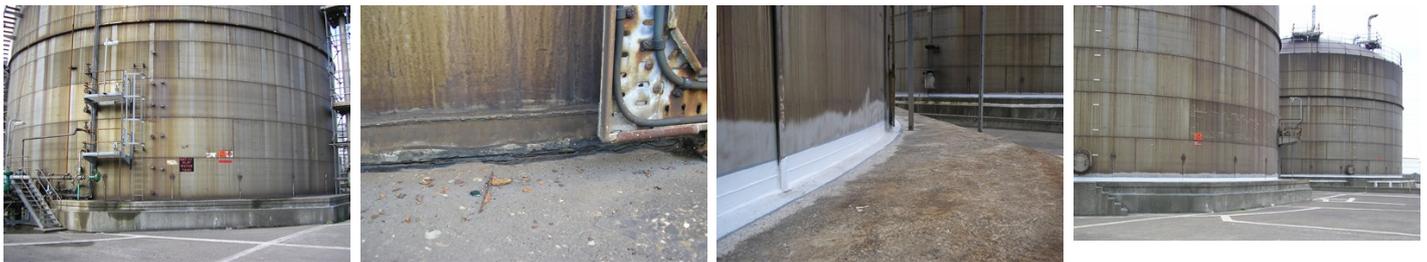
## Photograph Descriptions

Materials engineers on-site had highlighted that a stress corrosion cracking environment could be created if water was allowed to ingress under the tank floor.

- \* General view of Stainless Steel tank ,
- \* Close up of base prior to fitting the system ,
- \* Close up of the applied System ,
- \* Tank Base sealing Systems side by side ,

The application was carried out in accordance with Belzona System Leaflet GSS-3.
