Belzona coats a Hydro Power pump shaft

ID: 8235

Application: MPT-Mechanical Power Transmission

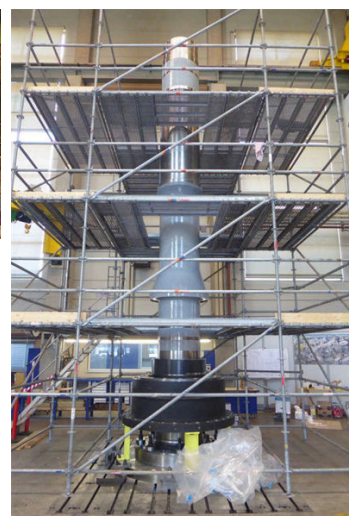
Conditions during operation: Head: 760 m, Power: 195 MW, Speed: 600 rpm Flow rate: 30 m³ / s. A slight increase in abrasion is to be expected within the new build.

In the course of a general refurbishment and performance increase of the pump, a new impeller was installed which changed the profile. This required a change in the contour of the shaft, which is where Belzona was required. The areas of the shaft in contact with water were coated with Belzona 5811.

The application was completed in accordance with Belzona System Leaflet MPT-01 and CEP-03.
